# Pelekane Bay Watershed Management Plan South Kohala, Hawaii

Prepared by  
**M. Carolyn Stewart**  
**Marine and Coastal Solutions International, Inc.**

May 31, 2005

**Mauna Kea Soil and Water Conservation District**

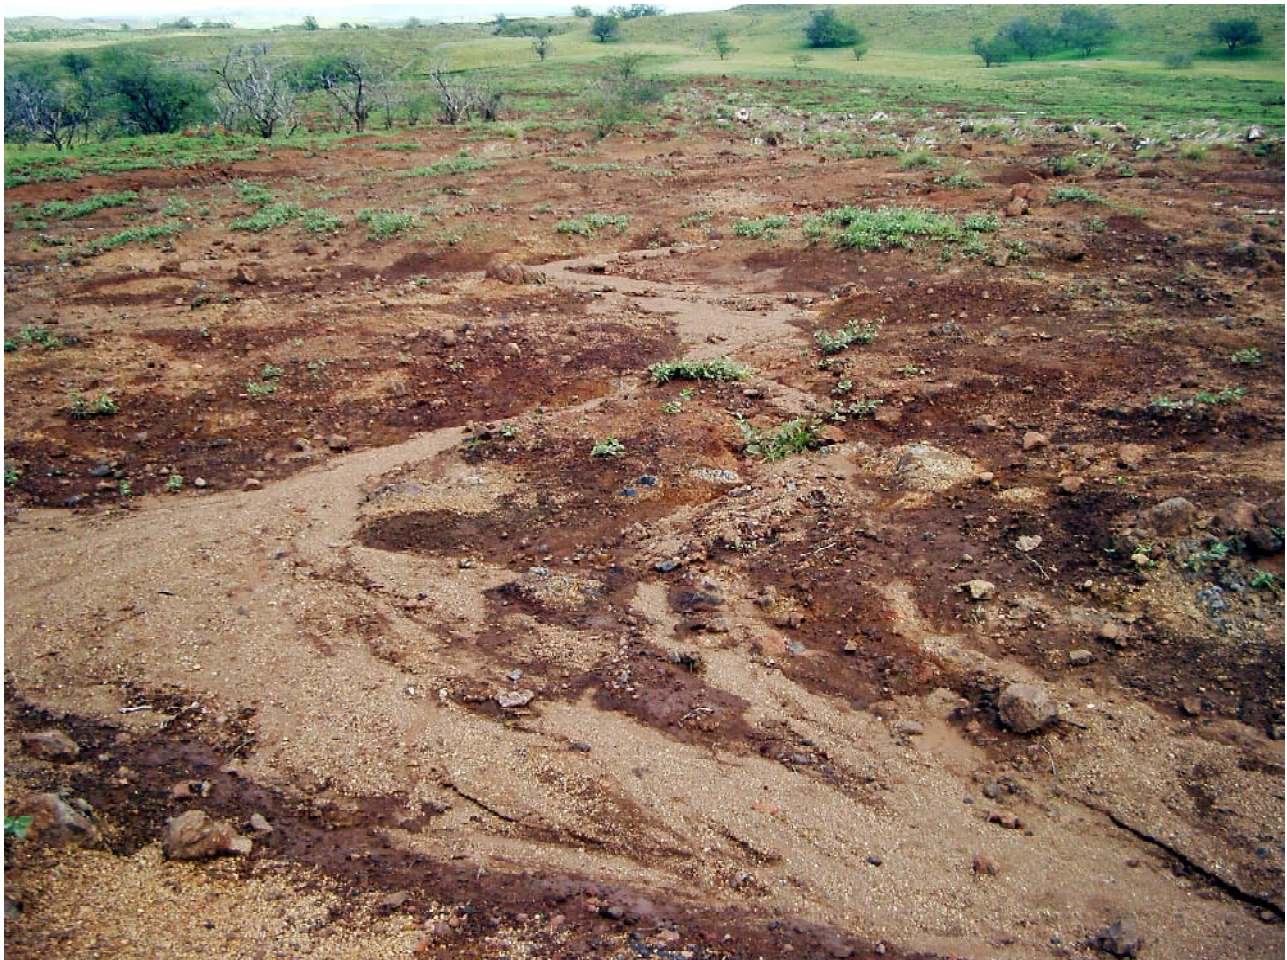
**Photo: Sediment movement in Paddock 4A**

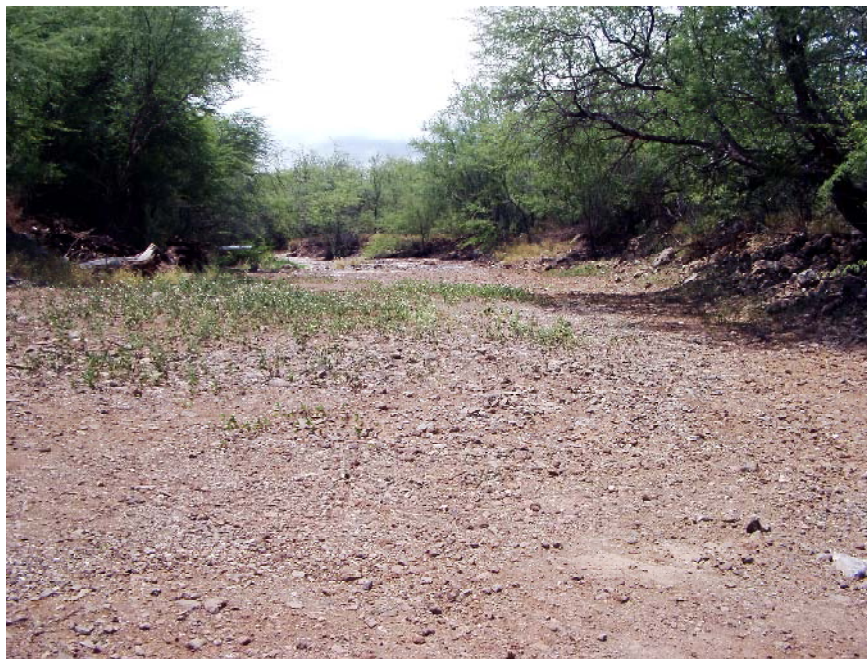
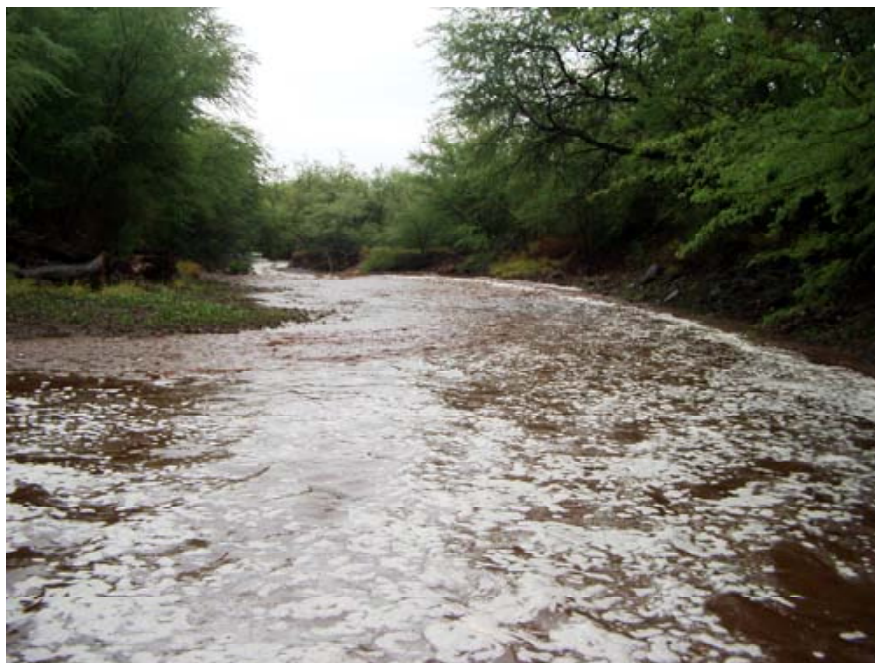
elevations. Streamflow is generally limited to flows in the gulches and overland during rainfall events. Localized heavy rainfall and storms cause flooding, called freshets or spates, which contribute to the flashy characteristic of Hawaiian streams. The photos in Appendix A provide a classic illustration of this flashy characteristic.

**Photos: Stream channel in normal dry condition (top) and following storm event (below)**

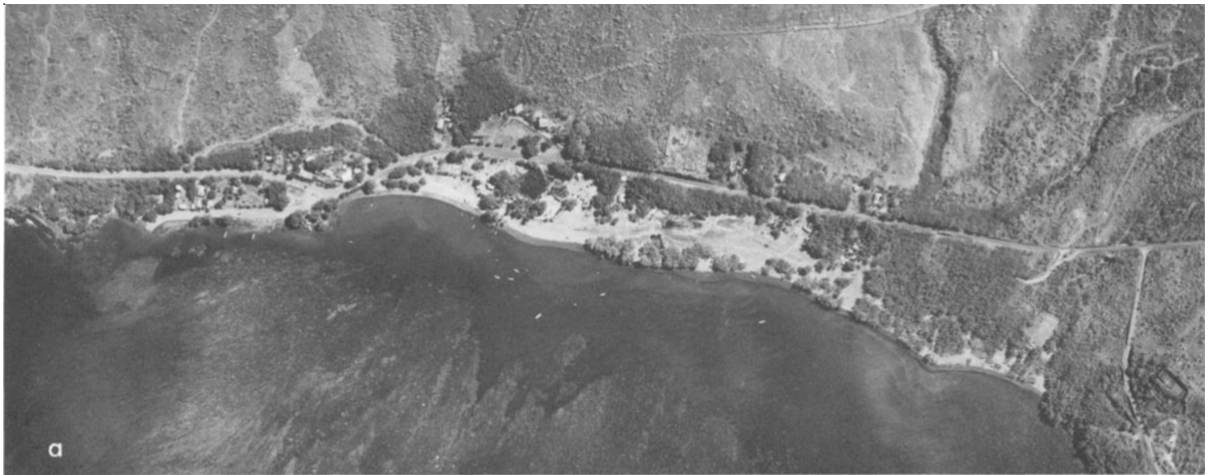
Experts have noted that much of the sediment retention in Pelekane Bay may be attributable to the lack of nearshore circulation caused by the construction of Kawaihae Harbor in 1959. In fact, Jokiel

**Photos: Kawaihae Bay before (top) and after (bottom) construction of Kawaihae Harbor in 1959**

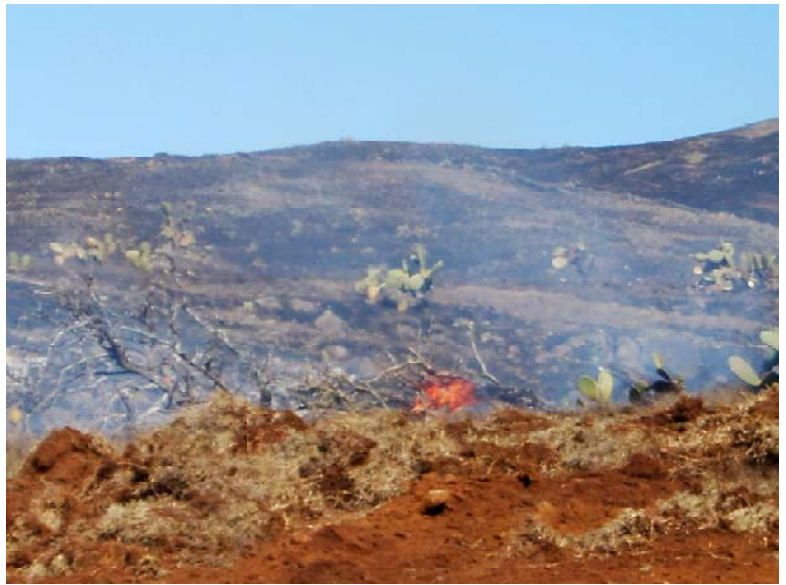
In November 2003, a fire accidentally started by private forestry workers burned 250 acres of grasslands in the watershed at Puu Loa, *mauka* of Kohala Mountain Road. Only the construction

**Photo: November 2003 Fire in the Upper Watershed**

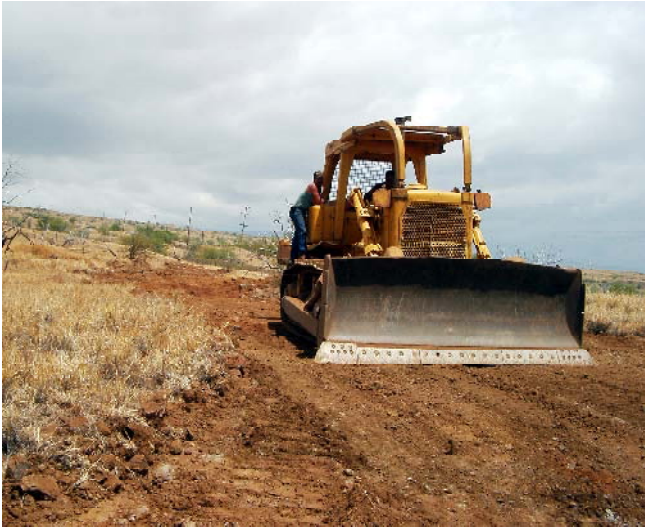
Fuel breaks can also be created by bulldozing a strip of a specific width to remove vegetation that would otherwise burn in a fire. This type of fuel break must be constructed with care to avoid wind and soil erosion and dust problems. In addition, it must be maintained regularly to keep it clear. Such fuel breaks have been created behind Catholic Charities’ Transitional Housing and adjacent to Kawaihae Village.

**Photo: Fire Break Construction**

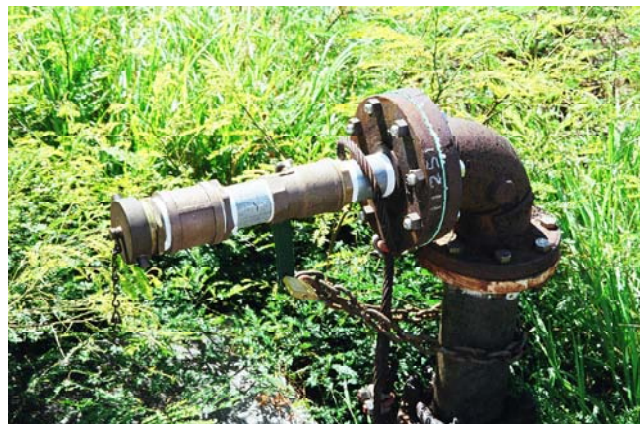
Measures implemented as part of the Pelekane watershed management project have enhanced Hawaii Fire Department access to water in the watershed. In 2002, the Hawaii County Department of Water Supply (DWS), partnering with the District, installed two standpipes (see photo below) on the county water line within the watershed to increase availability and access to water in the watershed for fire-fighting purposes. These standpipes will enable the Fire Department to attach hoses to fill tanker trucks and dip “frog” ponds for aerial fire control. In addition, DWS has recently agreed to allow Parker Ranch to draw water from these standpipes to supply troughs so that cattle can graze down the surrounding fuel load to enhance fire-fighter access and safety.

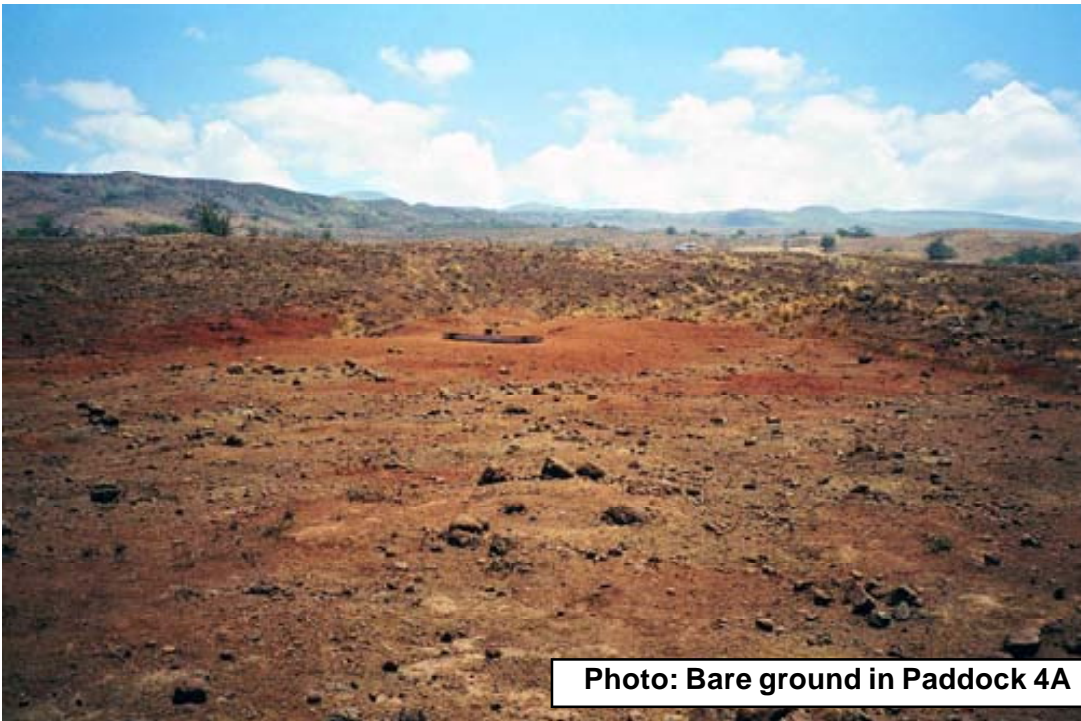
**Photo: Bare ground in Paddock 4A**

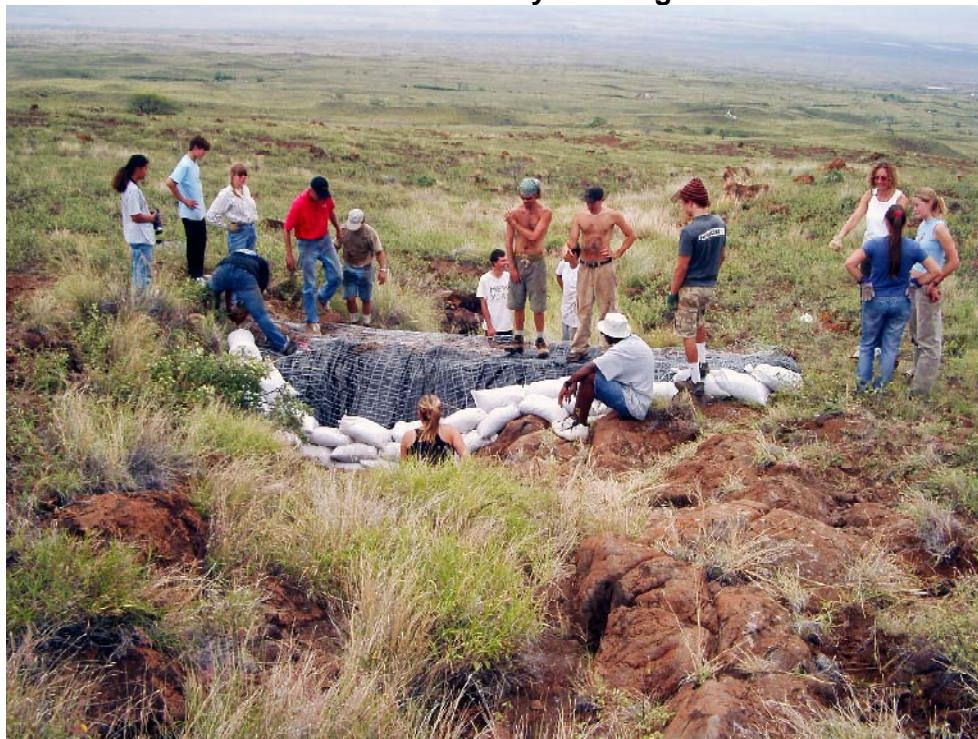
**Photo: At the end of the work day building the check dam**

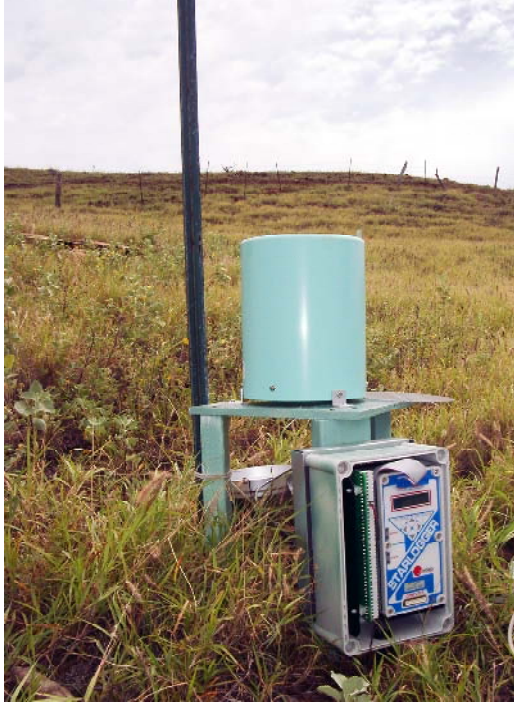
**Photo: Rain Gauge in Pelekane Watershed**

In November 2002, Dr. Michaud also installed two automatic rain gauges and data loggers in the watershed. These rain gauges enable the District to begin to make correlations between changes on the landscape and rainfall amounts. Over the long-term, they will help the District to obtain an understanding of the relationship between rainfall, runoff events, and sedimentation events in Pelekane Bay. Data from these rain gauges is downloaded periodically; data from September 2002 to February 2005 are summarized in Table 3 and in Figure 6.

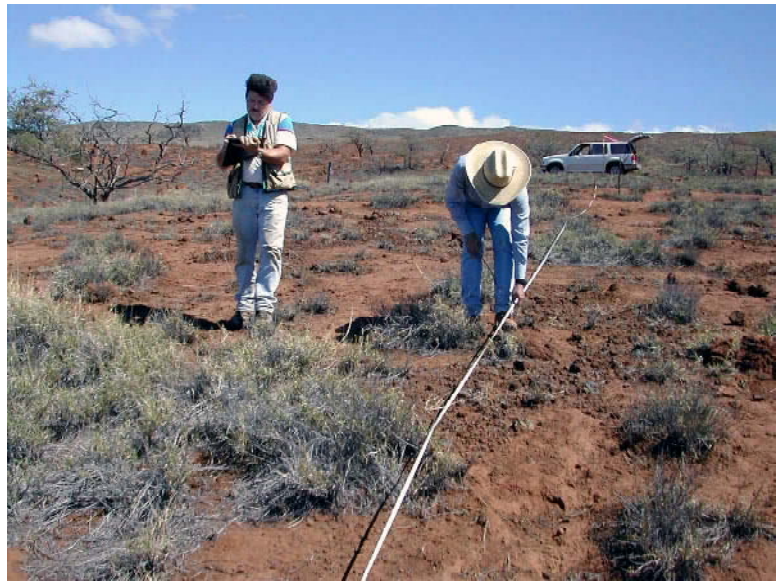
**Photo: Vegetative Cover Monitoring Transect**

A linear interval transect is used to monitor vegetational changes over intervals of time on a fixed line or location. A 100-ft. tape is stretched between two point and a 1-ft. interval used. A vegetational hit is recorded if all or part of the basal component of a plant lies totally or partially within that 1-ft. interval, directly under the tape. Bare ground, rock and litter are also recorded if they are at least one square-inch in area. To provide further precision, the 100-ft. line is subdivided into 20-ft. sections with subtotals calculated for each section. This helps more clearly define where changes in vegetation are actually occurring along the 100-ft. line.

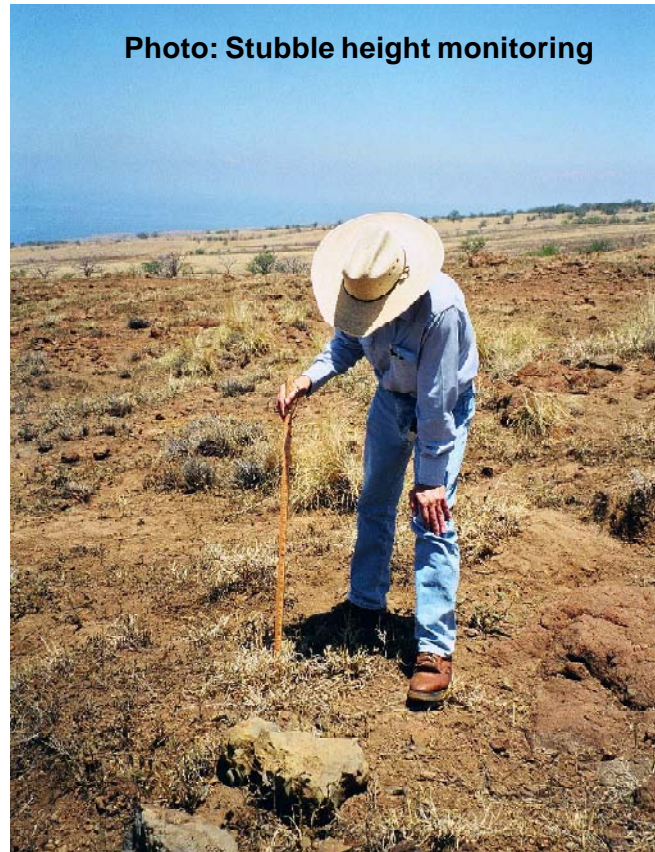
**Photo: Stubble height monitoring**

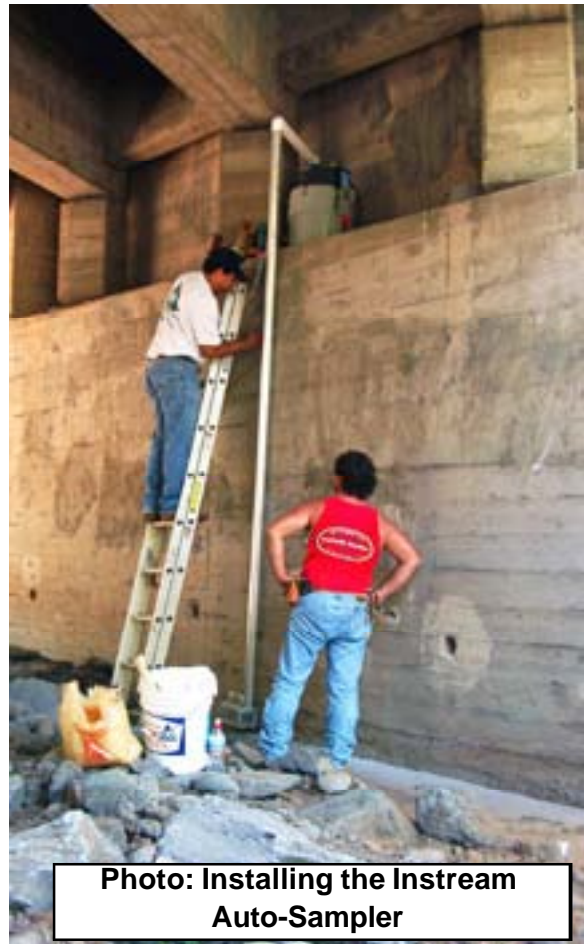
In May 2004, after waiting seven months for permission from the State Department of Transportation (DOT), an ISCO 6712C Compact Sampler, with flow module, was installed on a high ledge under the bridge over Makeahua Stream and secured to a concrete post. Figure 10 identifies the location of the autosampler. A pipe attached to the face of the bridge support contains the suction tubing and other wires. A cage at the bottom of the pipe contains and protects the water intake tubing. The flow meter is attached to the bottom of the cage. The sampler collects stormwater samples and flow rate data during times of stream flow.
